FIVE STAR HOME INSPECTIONS

Inspection Report

Property Address:
804 Inspection Lane
Washington UT 84780

Date: 11/3/2010	Time: 11:00 AM	Report ID: Lowe
Property: 804 Inspection Lane Washington UT 84780	Customer: Michael Lowe	Real Estate Professional: Randy Lowe Coldwell Banker

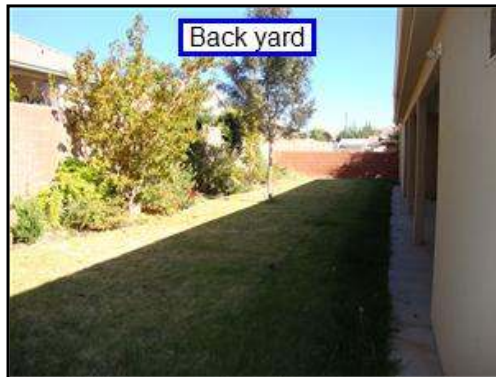
1.3 Picture 1

1.3 The front and back yard is in good condition with no injury hazards.

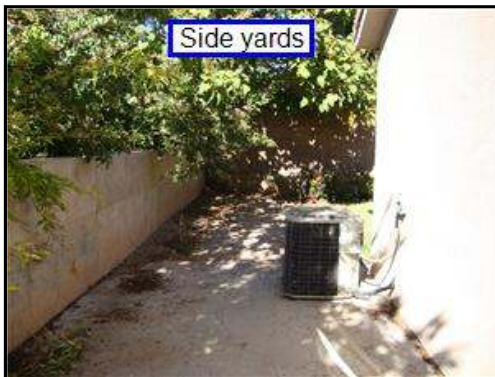
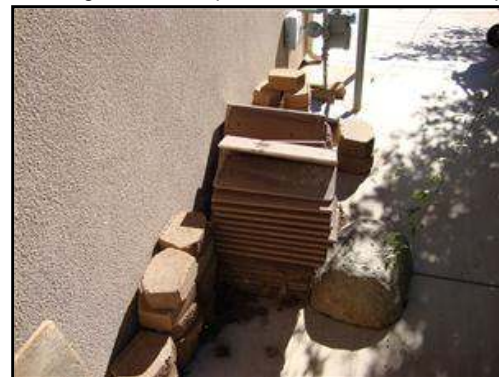
1.4 There is a lot of clutter on the left side of the home. I recommend cleaning the clutter up. This can cause unwanted pest in the future.

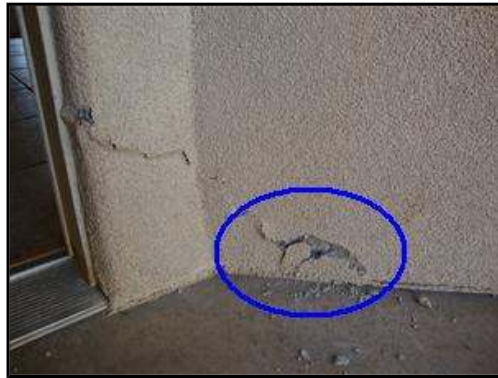
2.0 Picture 1

2.0 There is a small section of the stucco siding by the back patio door that needs to be repaired.

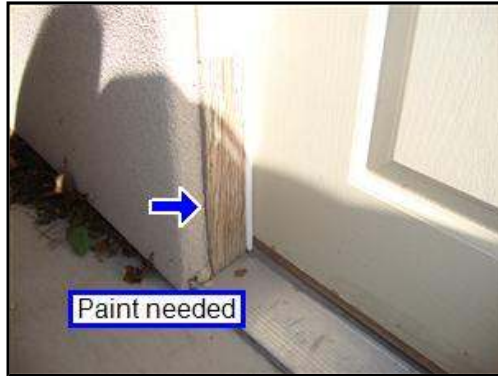
2.2 Picture 1

2.2 The door trim on the left side of the home needs to be painted. This door leads into the garage.

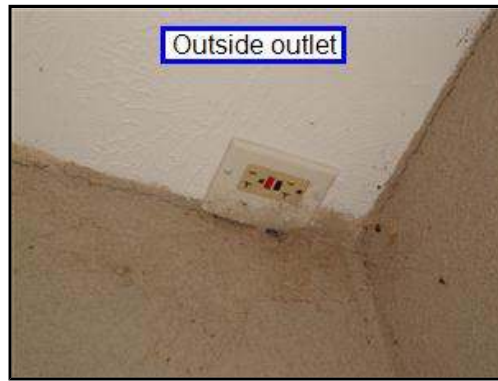
2.5 Picture 1

2.5 There is a outside outlet on the front patio that needs a weather proof cover installed.

All of the exterior outlets need to be GFCI protected for safety. The term GFCI stands for [Ground Fault Circuit Interrupter](#).

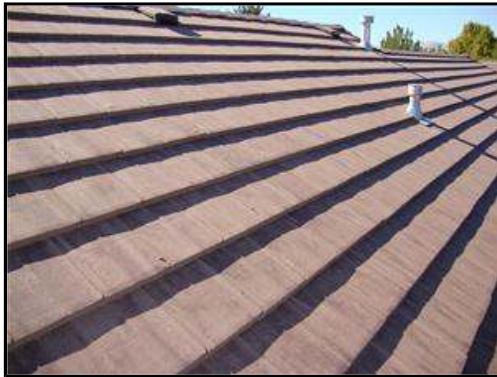
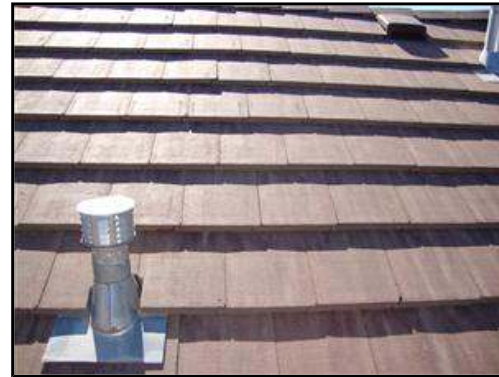
3.0 The roof is in really good condition. There is not one broken or cracked shingle. Tile shingles have a life span of 30 to 50 years.

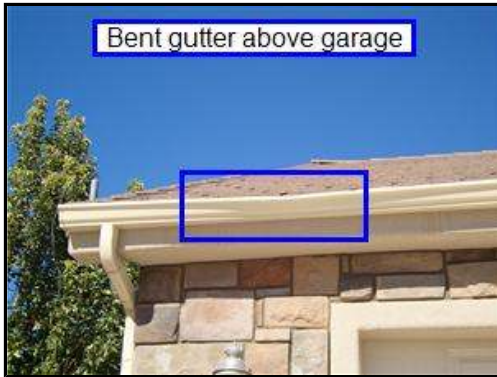
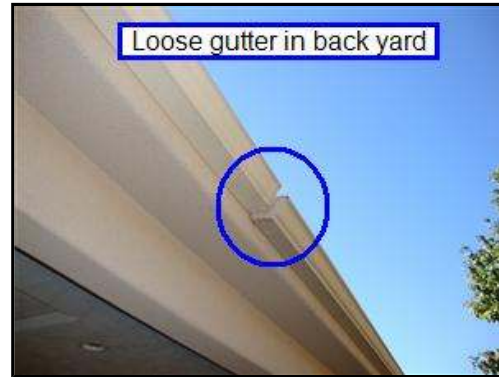
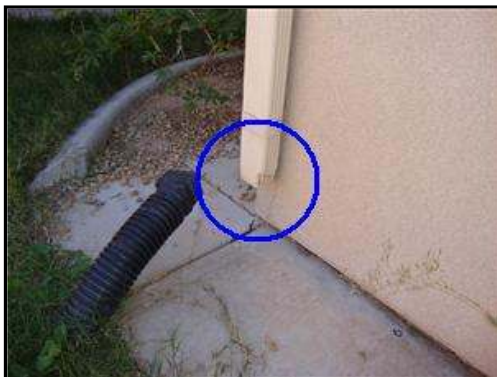
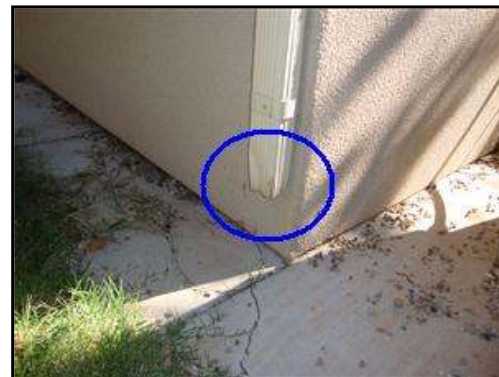
3.6 There is a section of the gutters in the front and back yard that needs to be repaired. Also there are 2 downspouts in the back yard that are missing there angle connectors. They needs to be replaced.

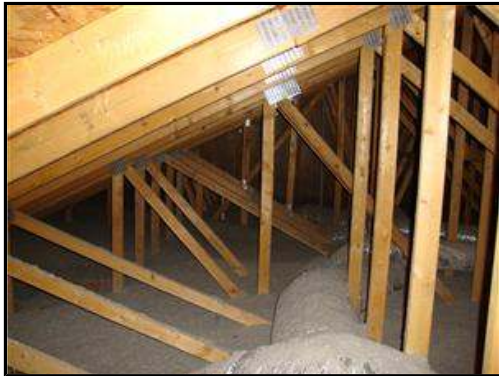
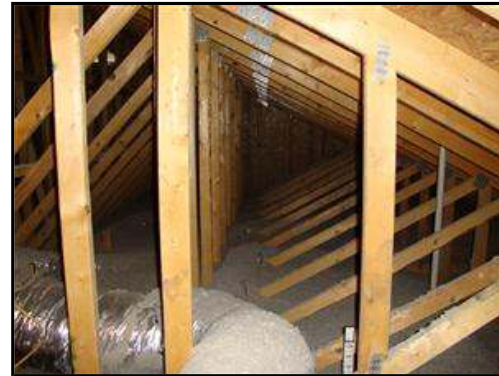
4.0 The attic is in good clean condition. This attic is one of the most cleanest i have inspected.

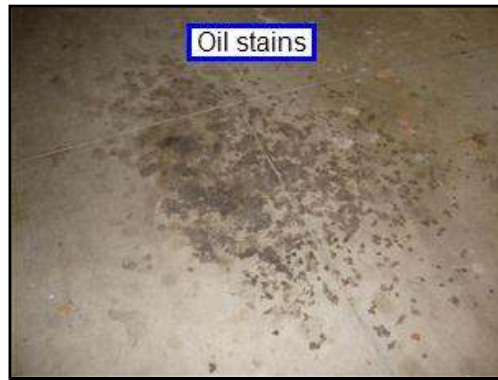
5.2 Picture 1

5.2 There are some oil stains on the garage floor that need to be cleaned up. This can be a fire hazard.

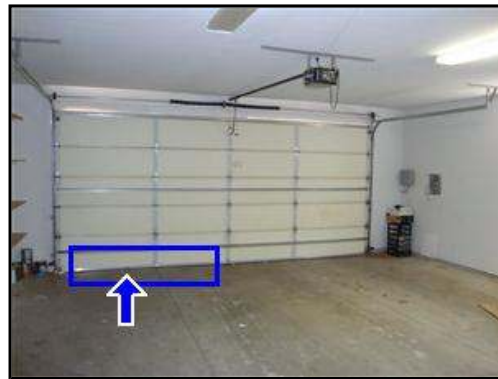
5.3 Picture 1

5.3 The bottom left of the garage door is a little bent. The door still opens and closes properly. I just wanted you to know.

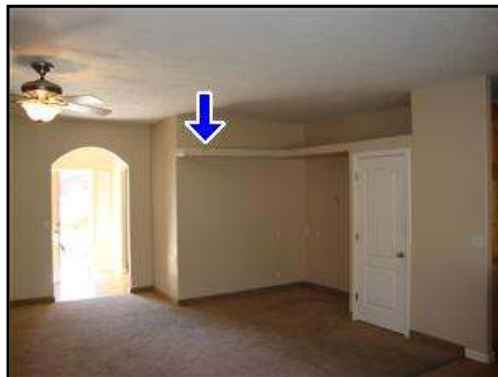
6.2 Picture 1

6.2 There is a kick out soffit in the living room. The soffit on the left side slopes down a little. The soffit is in sturdy condition. I just wanted you to know that there is a slope.

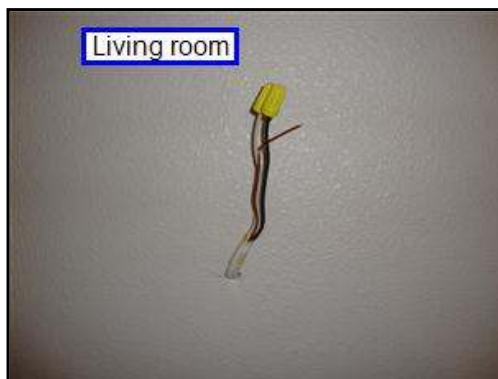
6.11 Picture 1

6.11 There is a electrical wire hanging out of the wall in the living room. I don't know if it is for a light or a outlet. The wire needs to be covered.

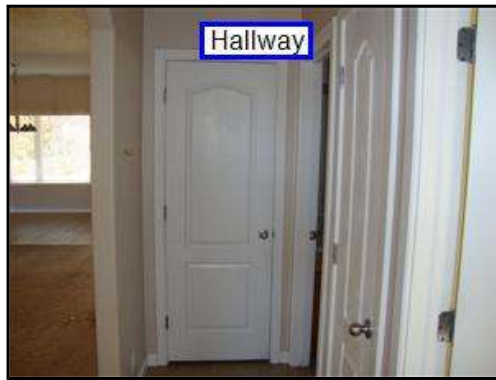
7.0 Picture 1

7.0 The hallways are in good condition. Everything works properly.

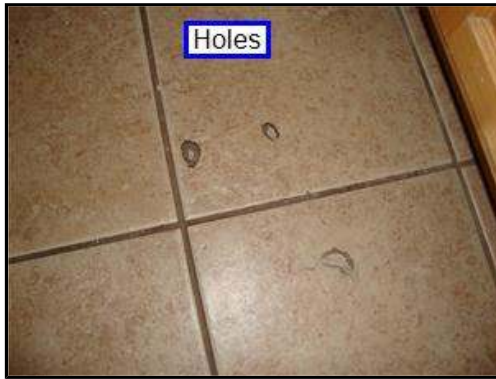
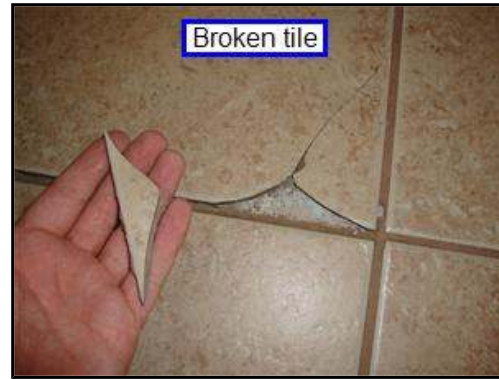
8.2 There are 2 small holes in the tile floor about a inch wide in the kitchen. There also is a small piece of the tile floor in the dining room that is cracked and pulling apart.

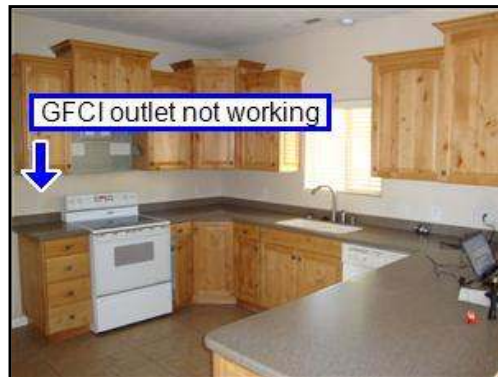
8.9 Picture 1

8.9 There is one GFCI outlet on the left side of the kitchen that does not work.

All of the kitchen outlets need to be GFCI protected for safety. The term GFCI stands for Ground Fault Circuit Interrupter.

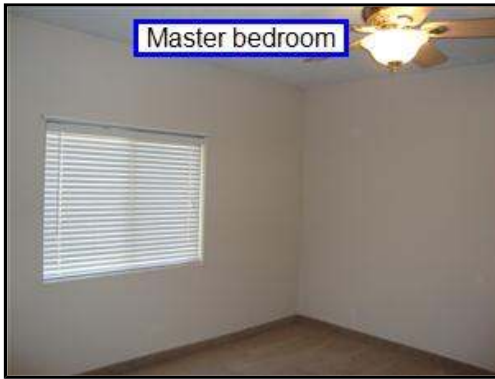
9.0 Picture 1

9.0 All 4 bedrooms are in good clean condition. Everything works properly.

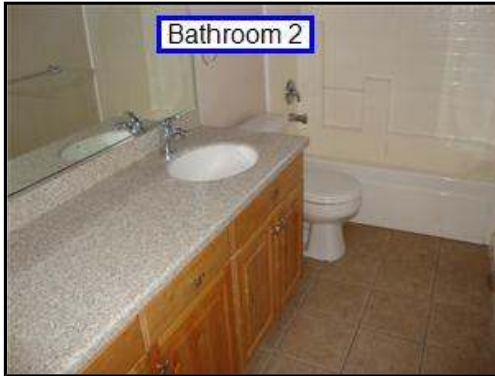
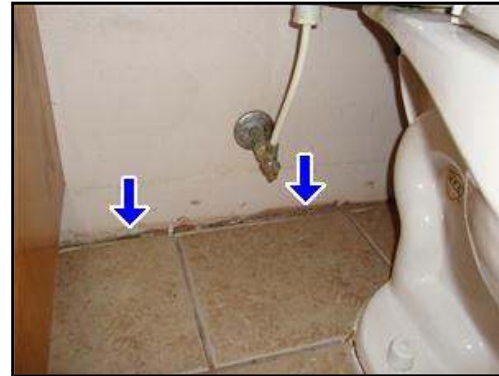
10.2 The bottom side wall behind the toilet in bathroom 2 needs to be sealed. There is a missing base board. The base board ether needs to be replaced or the wall needs to be sealed where the tile meets the wall.

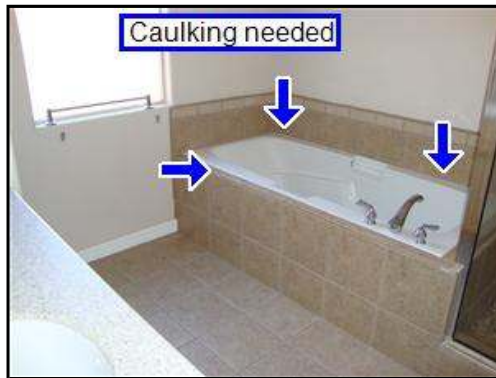
10.11 Picture 1

10.11 The bathtub in the master bathroom needs to be caulked around the edges.

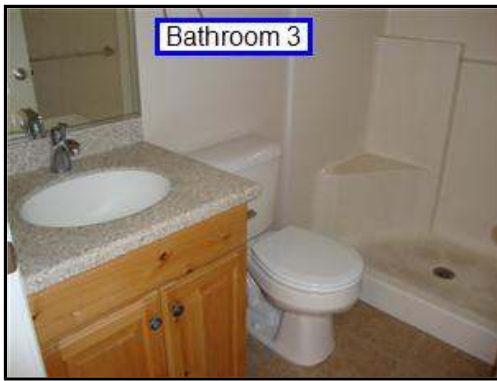
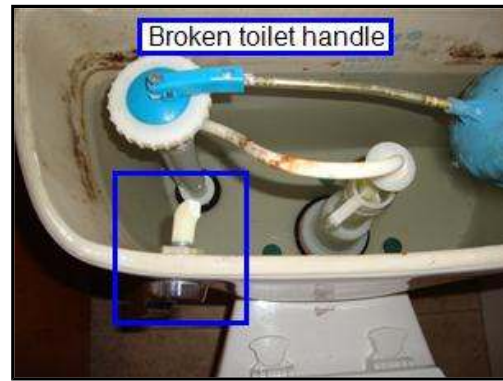
10.13 The toilet in bathroom 3 does not flush. Some of the guts need to be repaired.

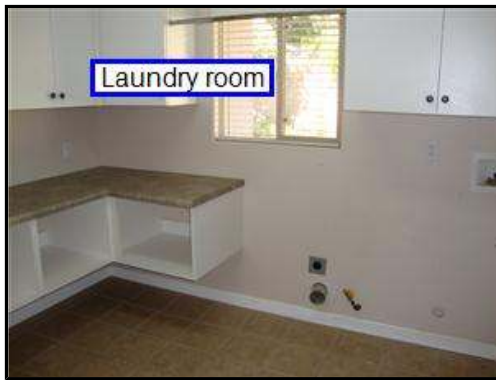
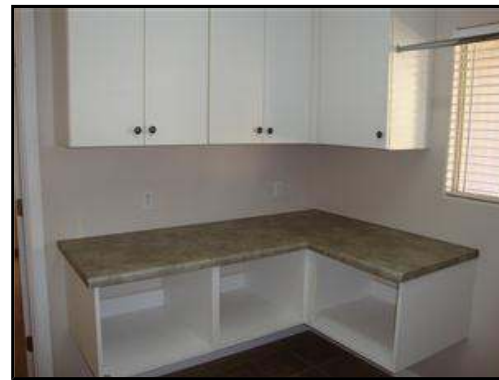
11.0 The laundry room is in good condition. Everything works properly.

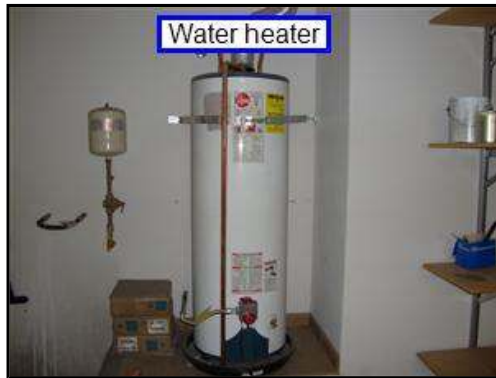
12.0 Picture 1

12.0 The water heater worked properly on the date of the inspection (11/3/2010) The unit is gas operated and is a 50 gallon tank.

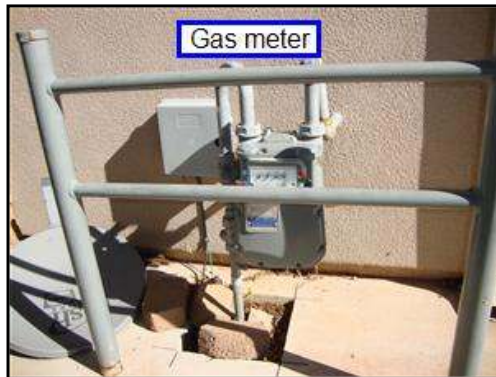
13.0 Picture 1

13.0 The gas meter is in good condition and is located on the left side of the home.

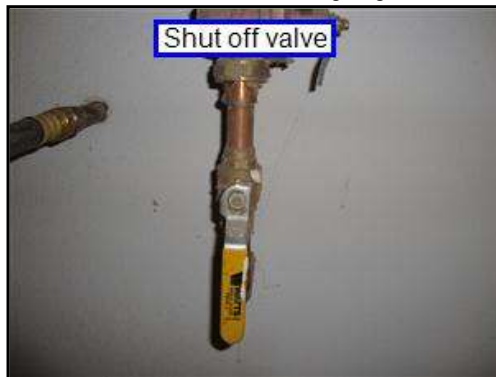
13.1 Picture 1

13.1 The main water shut off valve is in good condition and is located in the garage.

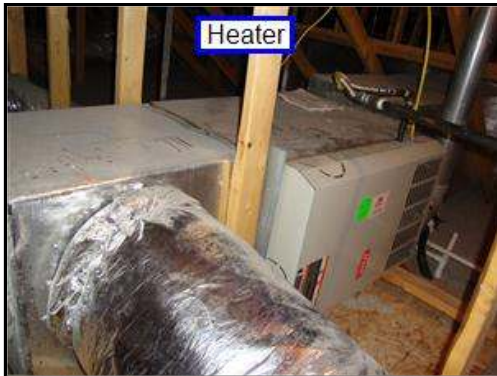
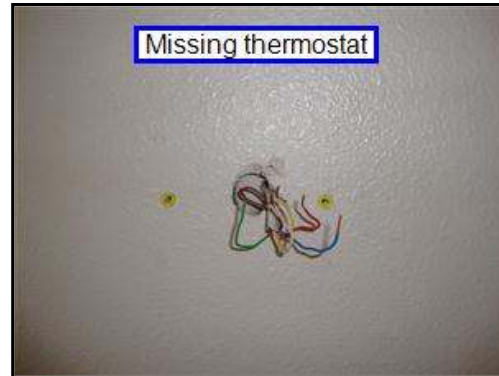
14.0 I could not inspect or run the heater or cooling condenser during the inspection because the thermostat that turns both units on and off is missing. I don't know if the previous owner took it when they left or what. I recommend having both units serviced because we do not know when the last time they were serviced.

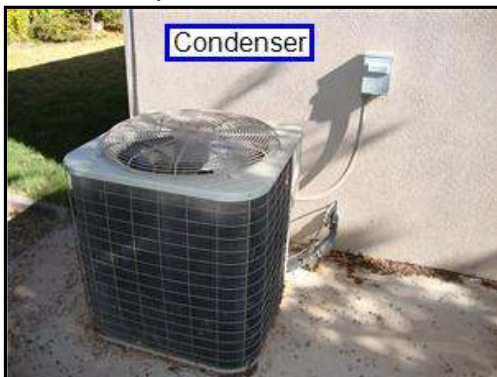
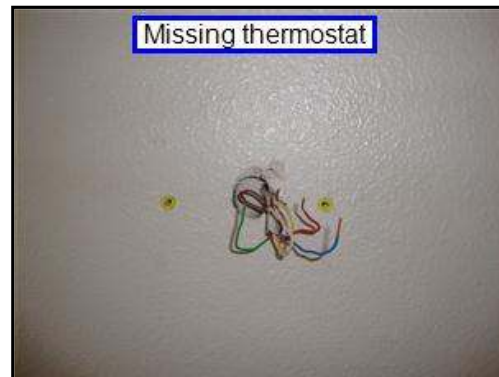
14.8 I could not inspect or run the heater or cooling condenser during the inspection because the thermostat that turns both units on and off is missing. I don't know if the previous owner took it when they left or what. I recommend having both units serviced because we do not know when the last time they were serviced.

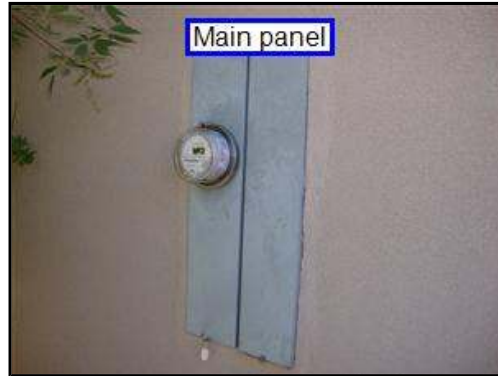
15.1 Picture 1

15.1 The main panel is in good condition and is located on the right side of the home.

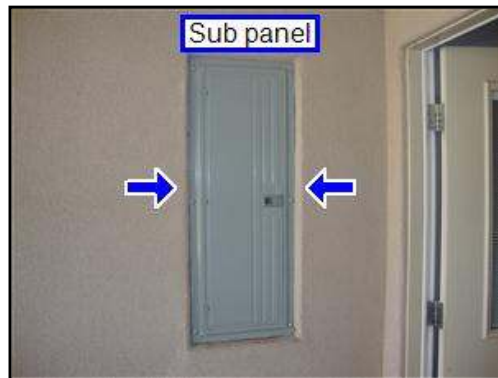
15.2 Picture 1

15.2 I could not inspect the inside of the sub panel because i could not get the panel door off. The panel is located outside on the back patio. The reason why i could not get the panel door of with out causing any damage to the siding of the home is because of the stucco siding.
